# ETICS solution for plastered masonry walls

Deliverable D2.3

| Project Title | Future-proofing Heritage Townhouses by Optimising Comfort and Energy in Time and Space |

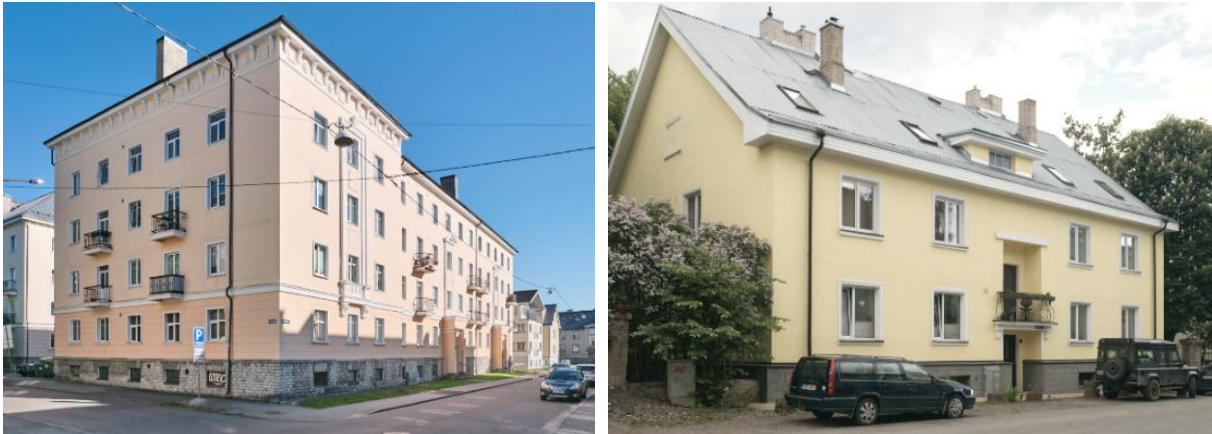
Figure 1: Kristiina and Sikupilli case study buildings are examples of different sizes of the Stalinist brick apartment building archetype (photos: Paul Klõšeiko).

Exterior walls of the Stalinist brick apartment building archetype have low hygrothermal performance: the measured thermal transmittances of the 2 case study buildings of this archetype were 1.1 and 1.5 W/(m<sup>2</sup>·K) for Sikupilli and Kristiina buildings respectively (see deliverable D2.1). This causes several issues:

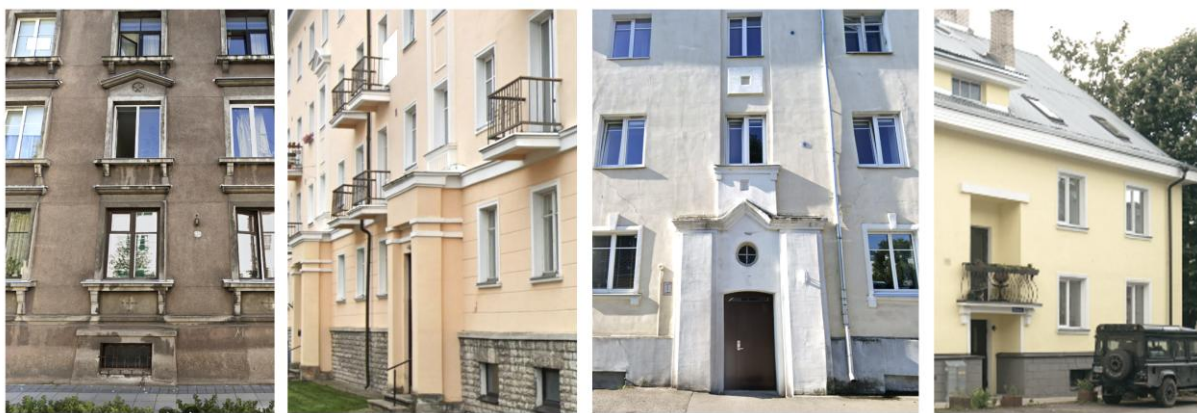
Figure 2: Examples of facade finish decor variations on the archetypical Stalinist brick apartment buildings (photos from left: Google StreetView, Paul Klõšeiko, Google StreetView, Paul Klõšeiko).

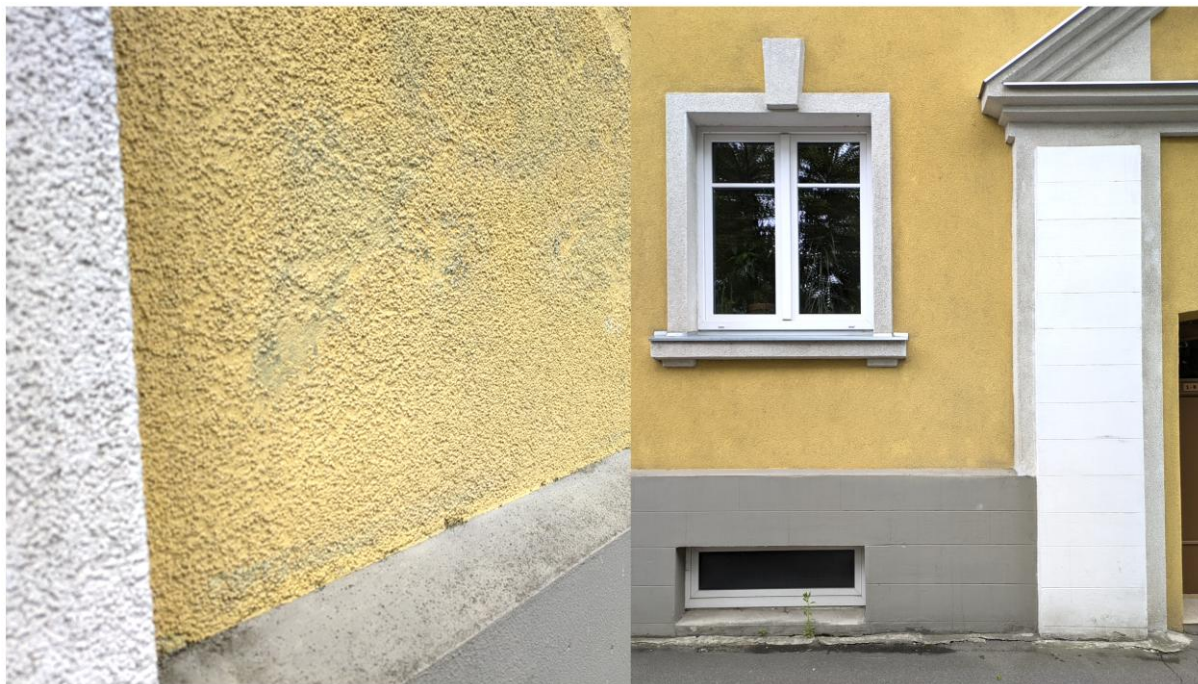
Figure 4: Finishing plaster with uncharacteristically large grain size can ruin the final result of the exterior insulation works (photos: Paul Klőšeiko).

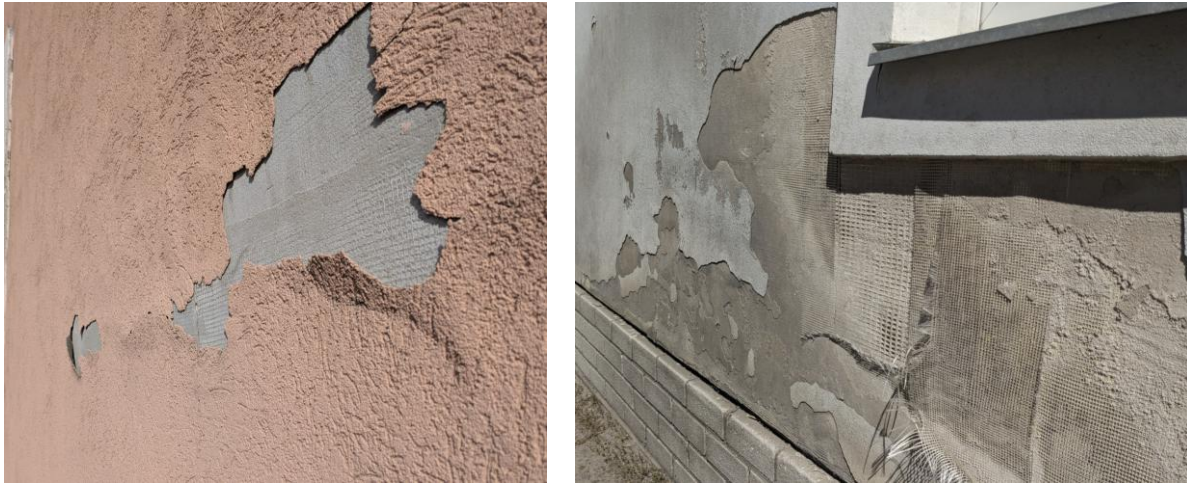
Figure 6: Examples of damage in ETICS facades: loss of adhesion between finishing and reinforcement layers (left) and extensive frost damage (right). Photos: Paul Klõšeiko.

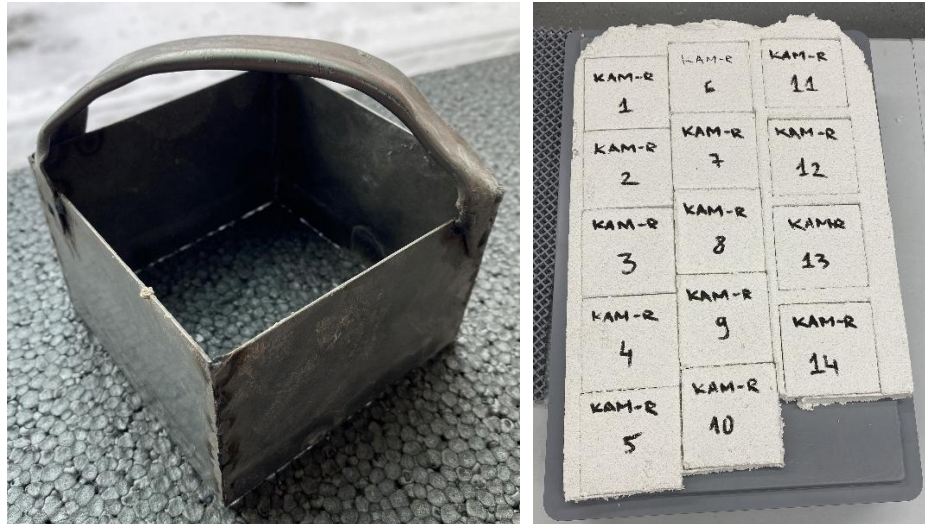
Figure 8: Left: Steel mold used to cut out plaster specimens. Right: KAM-R specimens after drying

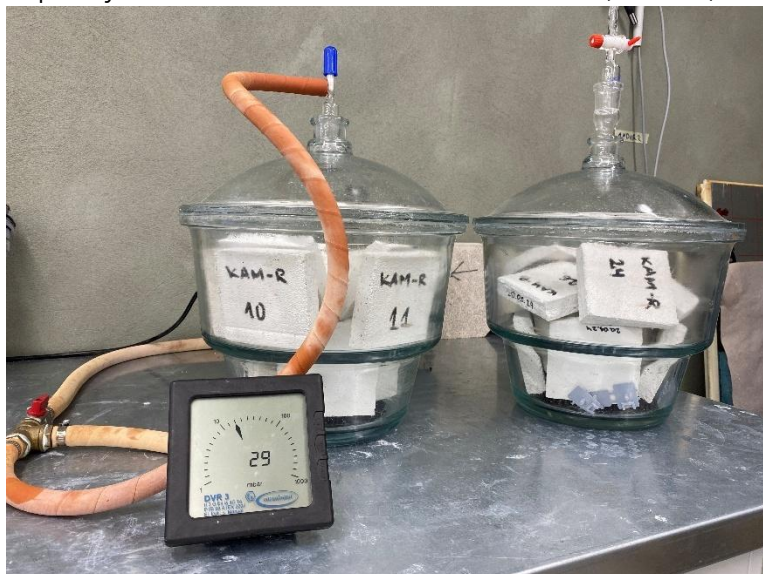
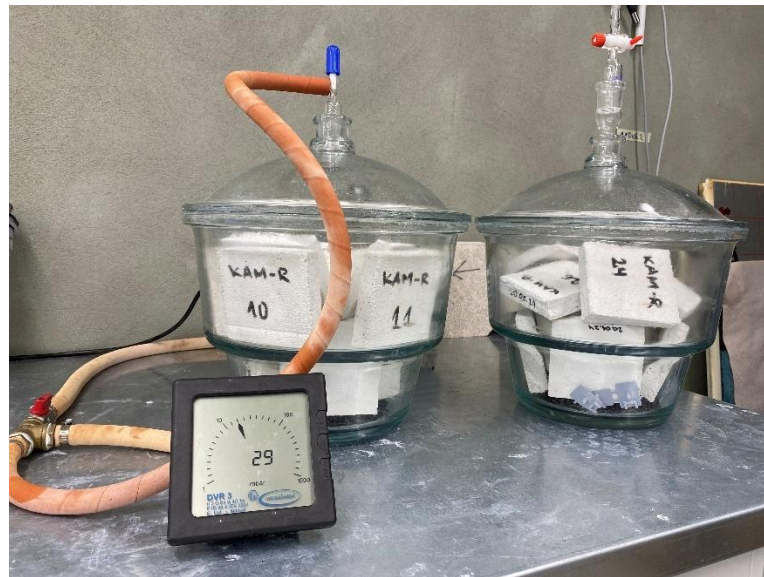
Figure 9: Vacuum saturation procedure of KAM-R specimens

Figure 9), capillary saturation at  $\approx 70\%$ , equilibrium moisture content at 97% RH ( $\approx 30\%$ ), and an intermediate level of  $\approx 45\%$ . Moisture conditioning involved vacuum saturation followed by controlled drying to the target levels in a ventilated chamber to ensure homogeneous moisture distribution and reproducible freeze-thaw exposure.

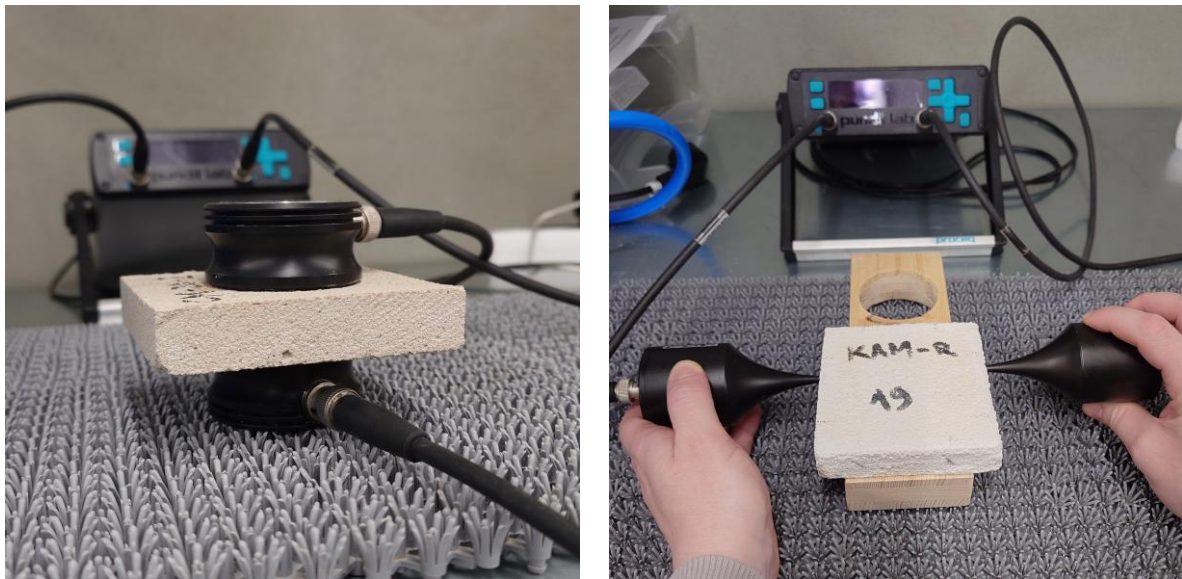
Figure 12: UPV through-thickness test setup (left) and in-plane test setup (right).

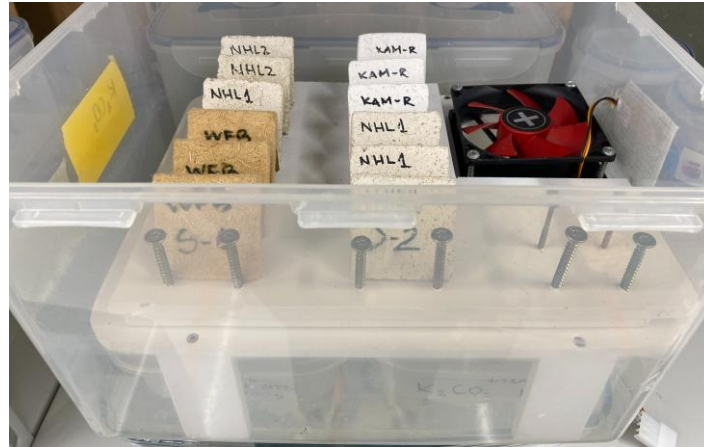
Figure 14: Desiccator used for hygroscopic moisture retention measurements. The specimens were conditioned above a supersaturated salt solution, while an internal fan provided air circulation to promote uniform relative humidity within the chamber.

**The moisture retention behaviour in the hygroscopic range** was determined using **the desiccator method** in accordance with EN ISO 12571:2021 with minor modifications (Figure 14). Measurements were performed on 50 × 50 × 5 mm specimens of the plaster materials at a temperature of 23 °C. Prior to testing, the plaster specimens had undergone approximately four months of curing and carbonation under laboratory conditions (23 °C, 50% RH). The specimens were exposed to controlled relative humidity environments generated by saturated salt solutions corresponding to 43% RH (K<sub>2</sub>CO<sub>3</sub>), 75% RH (NaCl) and 97% RH (K<sub>2</sub>SO<sub>4</sub>). Both adsorption and desorption paths were investigated by sequentially conditioning the specimens at the selected humidity levels until mass equilibrium was reached. The equilibrium moisture contents obtained at each humidity level were used to construct the hygroscopic portion of the moisture retention curve. To define the upper boundary of the moisture storage function, the moisture content at 100% RH was assumed equal to the vacuum saturation moisture content determined separately using the vacuum saturation procedure.

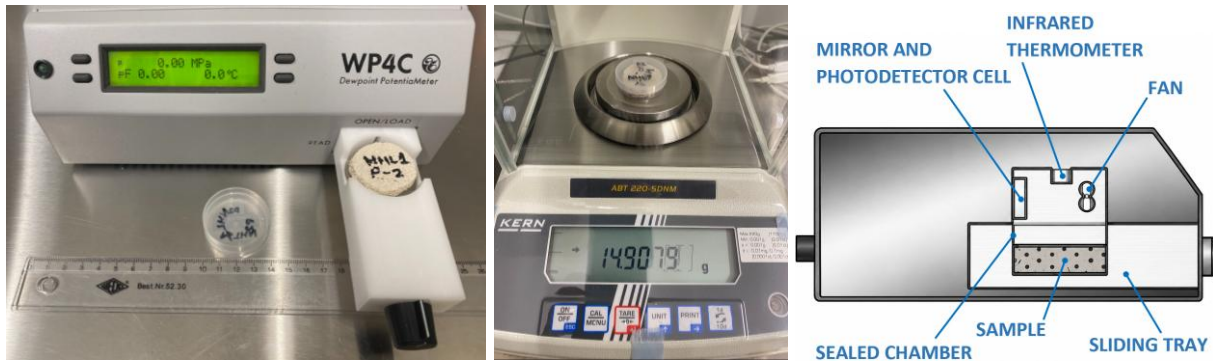
Figure 16: Dew point psychrometer (Meter Group WP4C) used for moisture retention measurements in the overhygroscopic range (left), gravimetric determination of specimen moisture content (middle), and schematic illustration of the dew point psychrometer measurement principle (right).

between the moisture in the specimen and the water vapour in a sealed measurement chamber. The dew point temperature of the chamber air and the specimen temperature are measured, allowing the corresponding relative humidity and moisture potential to be determined. Specimens were conditioned to different moisture states prior to testing, and the resulting equilibrium moisture contents were combined with the pressure plate and desiccator measurements to construct the complete moisture retention curve.

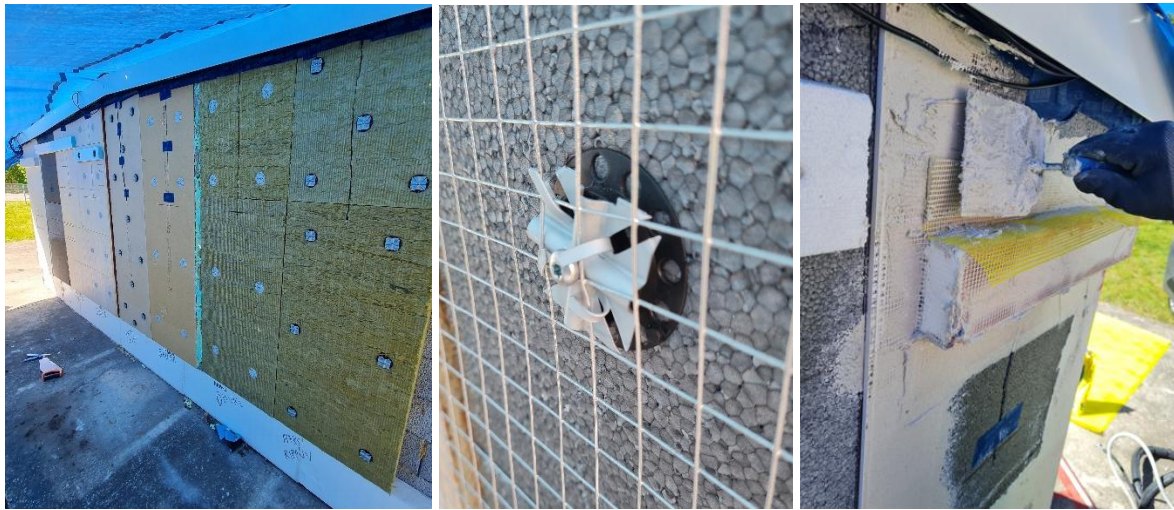
Figure 24: Insulated façade under scaffold sheeting before plastering (left); steel mesh for the thick plaster system and a mesh fastener on top of an insulation anchor (center); application of lime-cement (L/C) plaster and reinforcement profiles at the XPS corners on top of the EPS insulation (right).

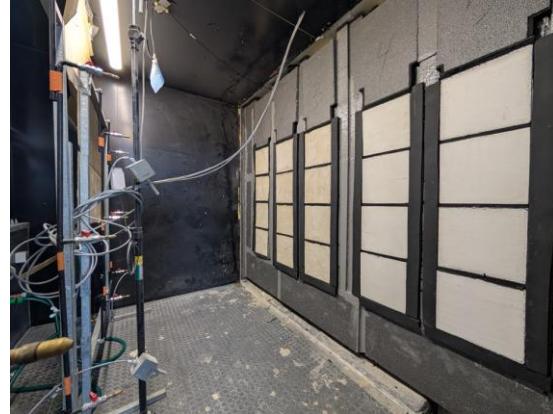
Figure 27. Schematic of the test sample (left) and samples installed in the climate chamber, spray nozzles for rain simulation are also visible (right). (Klöße et al., 2026)

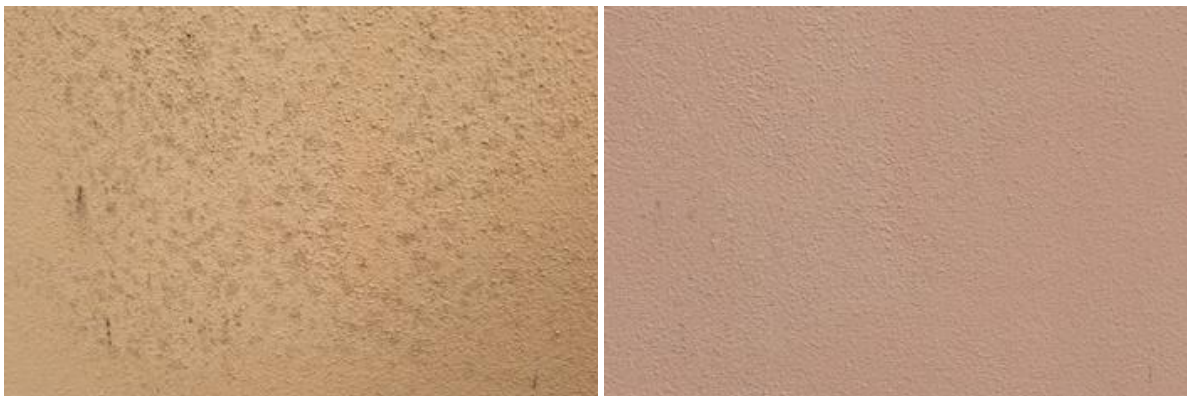
Figure 31: Biological growth on 25 March 2025 on the thick plaster (NHL system) on wood fibre board insulation all over the section on southern facade (left) and same area on 07 August 2025 (right). (Talvik et al., 2025)
