HeriTACE

# Improving energy efficiency of historical windows

Deliverable D2.5

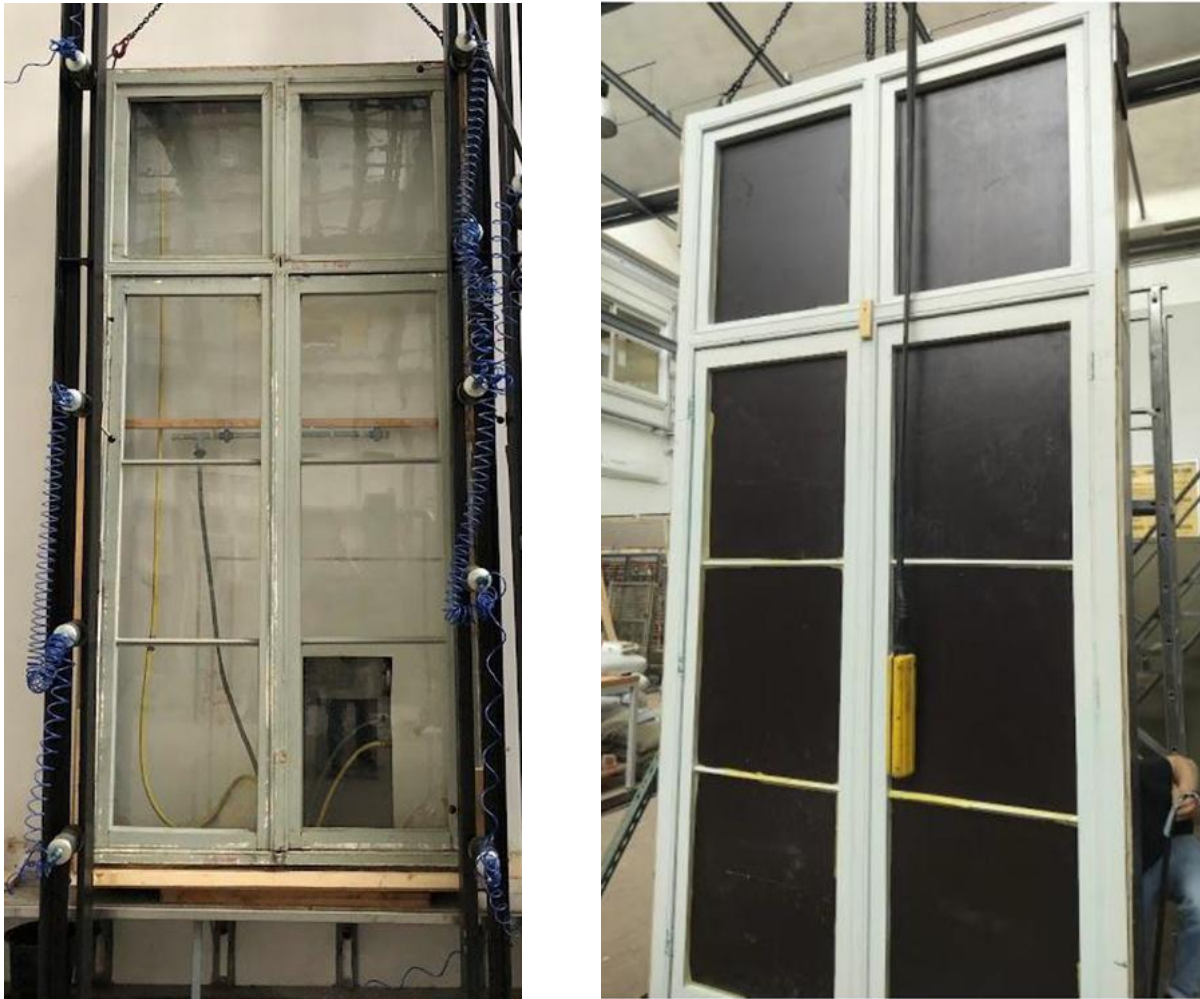
Figure 5 Original and refurbished window Rozier

The same window was refurbished and tested again for comparison. In the refurbishment the wood was sanded, corrections were made to render it level, and a gasket was installed. Again, the proper hardware was not installed before the test, and as the glass was not yet installed, plywood panels were used during the test (it is presumed this does affect the test results).

The air leakage rate of the original window amounted to  $23.03\text{m}^3/\text{h.m}^2$ , whereas the refurbished window resulted in an air flow rate of  $17.22\text{m}^3/\text{h.m}^2$  @50Pa pressure difference. Even though there is a slight improvement of the performance, the leakage class remains 1 in both cases. Watertightness tests pointed out that both configurations failed when subjected to a rain load without pressure difference, resulting in classification A0.

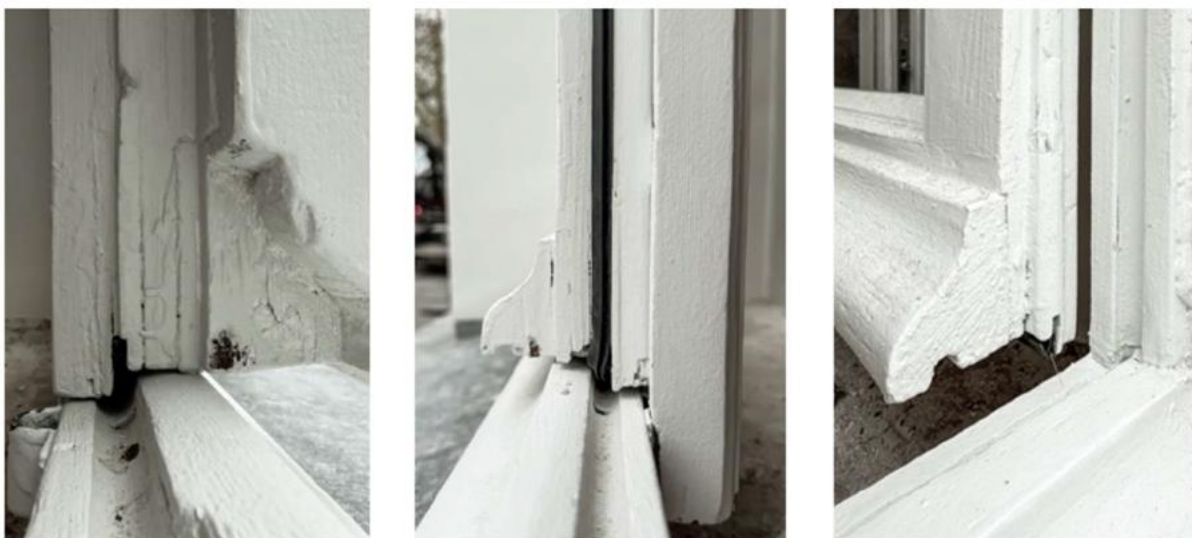
Figure 11 Refurbished window with single gasket. Pictures and horizontal section.

For the in-situ restoration configuration (sRE3a), no rubber gasket was installed at the perimeter joints. These locations were deliberately left untreated in order to minimise the risk of damage to the historic joinery and to preserve the minimally invasive character of the intervention. During the subsequent workshop restoration sequence, sealing elements were introduced at these joints, allowing the influence of this additional intervention on airtightness performance to be evaluated separately.

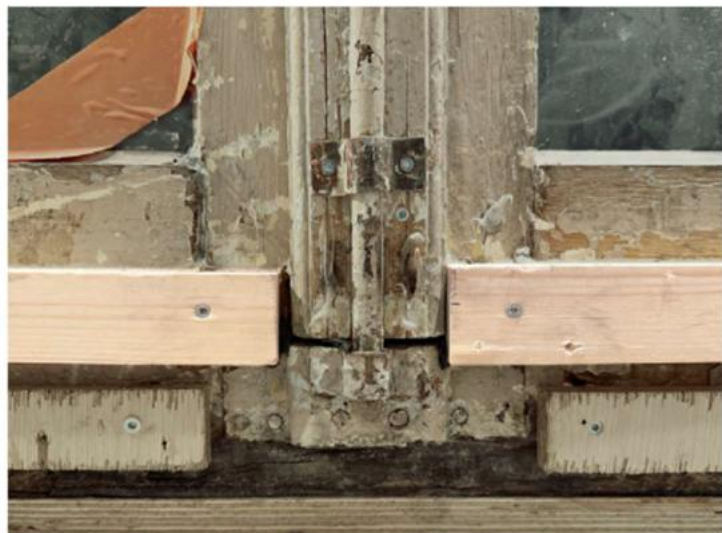
Figure 13 Original window with interior gasket configurations. Pictures and horizontal section.

The use of cover strips offered several advantages from an experimental perspective. The intervention was largely reversible, reduced the risk of damage to the historic joinery, and allowed visual inspection of the contact zone between gasket and timber. Furthermore, the configuration enabled the effect of introducing a new sealing plane to be investigated without extensive modification of the original frame-sash geometry.

To accommodate the cover strips, the original hinges were replaced and repositioned. This modification was necessary to ensure the technical feasibility of the proposed sealing arrangement within the constraints of the existing window geometry.

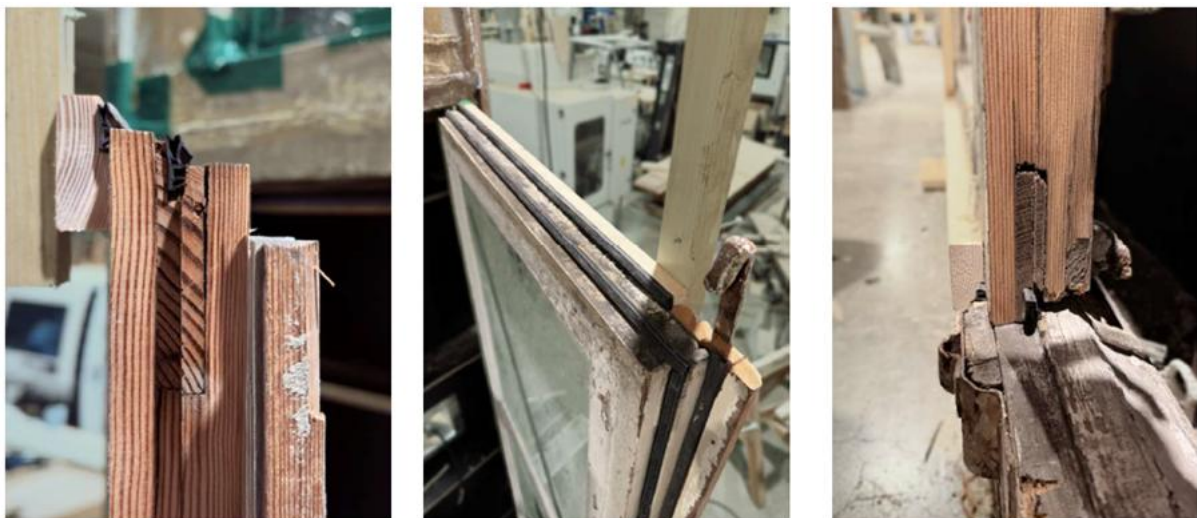
Figure 15 Original window with interior and central gasket configurations.

The configuration was introduced to assess the combined effect of a primary sealing interface at the original frame-sash contact plane and a secondary sealing interface located on the interior side of the window. Compared with the center-exterior configuration, this arrangement allowed the influence of sealing-plane location to be investigated while maintaining the same number of sealing interfaces.

Due to geometric constraints near the upper corner of the sash, the interior sealing line could not be installed as a fully continuous perimeter gasket. Consequently, local interruptions remained within the sealing plane. Additional measures were implemented in the laboratory setup to approximate the behaviour of a continuous gasket and to evaluate the influence of these discontinuities on the measured airtightness performance.

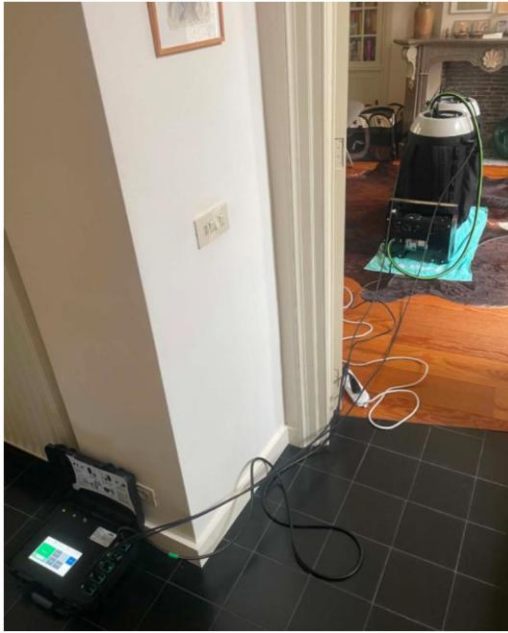
The Pulse system was installed inside, the compressed-air vessels were positioned as centrally as possible within the ground-floor space to promote a uniform propagation of the pressure wave throughout the building. To minimise reflections and measurement disturbances, a clearance of at least 1 m was maintained around the vessels. The controller and pressure sensors were positioned outside the direct path of the pressure wave, typically at the maximum cable distance from the air-release vessels. Before each measurement sequence, the system recorded ambient pressure conditions for approximately 30 to 60 seconds in order to characterise background pressure fluctuations caused by wind and stack effect. A short compressed-air pulse of approximately 1.5 to 2 seconds was then released into the building, generating a pressure increase typically between 4 and 10 Pa. Pressure and temperature data were recorded at high frequency throughout the measurement process. The measurement software used the recorded pressure response together with the known volume of compressed air released from the calibrated pressure vessels to determine the leakage coefficient and flow exponent through iterative fitting of the Power Law relationship. The primary output of the method was the leakage flow rate at 4 Pa ( $Q_4$ ), which was subsequently extrapolated to 50 Pa ( $Q_{50}$ ) to enable direct comparison with blower door measurements. For each test configuration, a minimum of three valid Pulse measurements was targeted. Measurements were considered valid only when the resulting flow exponent remained within physically meaningful limits and when the goodness-of-fit of the model exceeded the acceptance threshold implemented by the manufacturer. When a valid result could not be obtained, the equipment position was adjusted and the measurement repeated.

Figure 19 Setup of pressure vessel and controller to avoid direct interaction

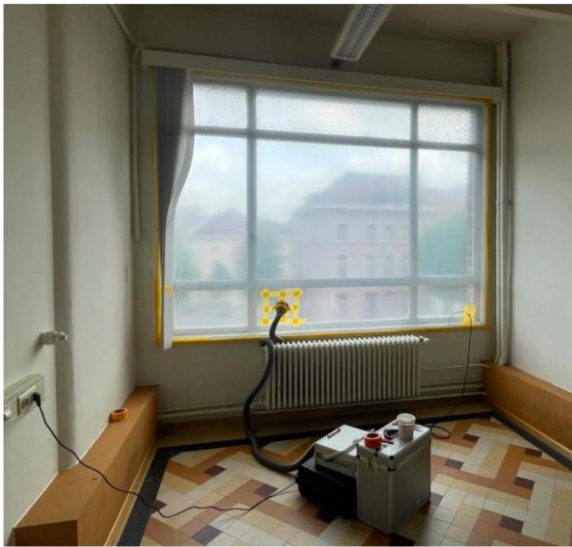
A limited number of exploratory measurements were carried out to investigate the feasibility of using the Pulse method for component-level airtightness assessment. The approach consisted of comparing measurements of a room before and after temporarily sealing the tested window with an airtight membrane. The resulting leakage estimates were compared with reference measurements obtained using a Lindab Ltest system at 4 Pa, originally developed for testing the airtightness of ventilation ducts. The results showed large deviations, ranging from 59% to 99%, and in one case even produced a physically impossible outcome in which the room appeared leakier after the window had been sealed. These findings indicate that the differential masking approach is currently unsuitable for accurately isolating the leakage contribution of individual windows. Nevertheless, measurements performed in simple single-room configurations demonstrated excellent reproducibility and a 100% operational success rate, suggesting that the Pulse method itself remains highly reliable in geometrically simple environments. Perhaps the use of the foil on the inside of the window entailed a sudden drop in pressure due to the movement of the foil, in turn yielding a pressure loss that is not realistic.

Figure 24 On site testing of window airtightness using Lindab duct testing equipment

In addition to whole-building testing, a limited number of component-level measurements were performed to investigate whether the Pulse method could isolate the airtightness of individual windows. Two measurements were carried out on a historic timber window and one on a steel-framed window. Results were compared with reference measurements obtained using a Lindab Ltest system at 4 Pa.

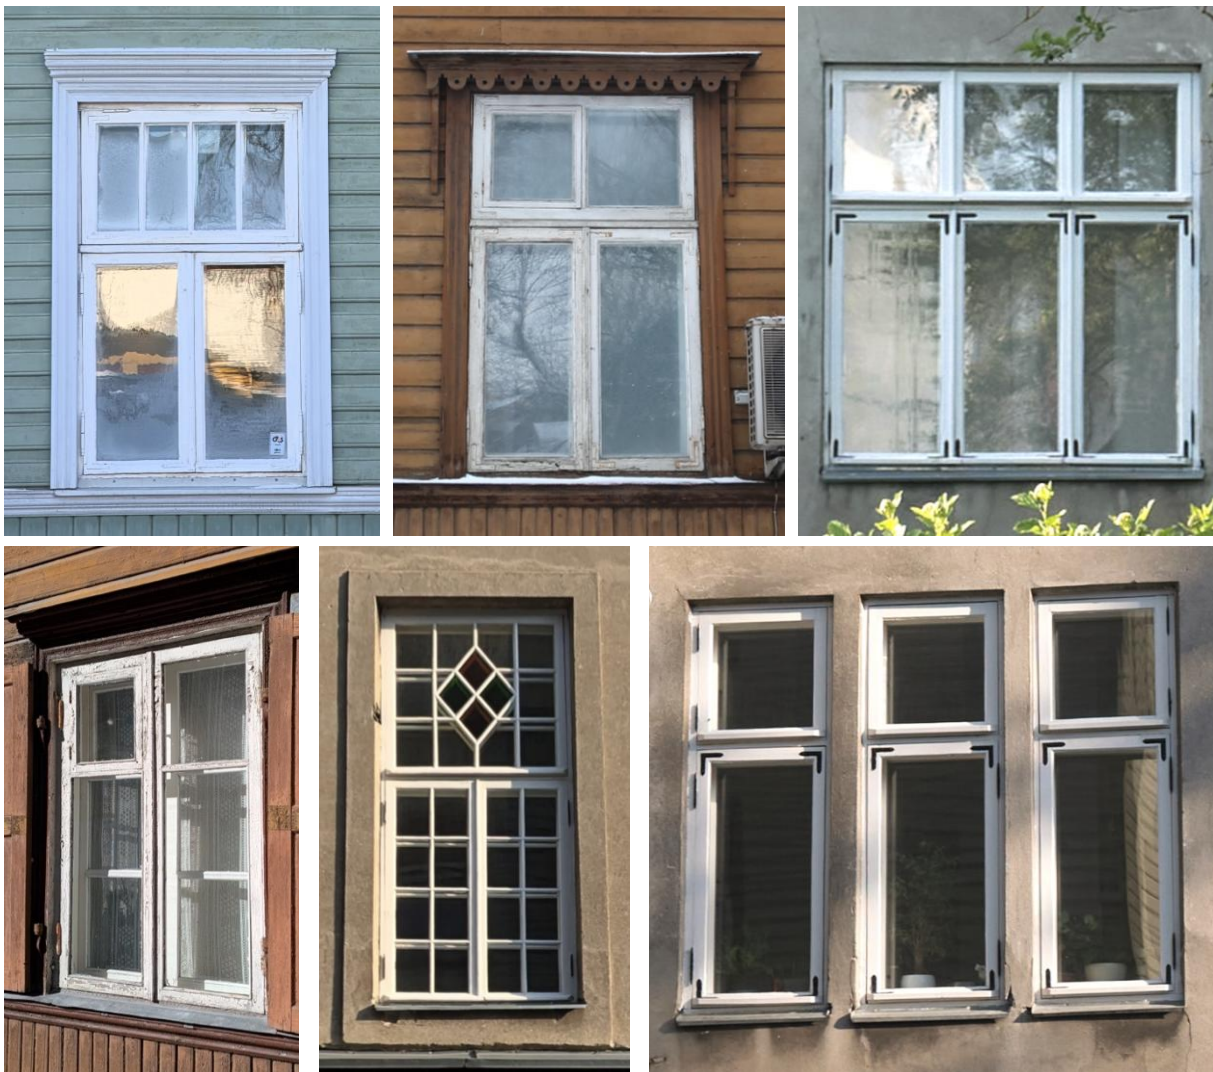
Figure 29 Examples of different configurations of the targeted window type.

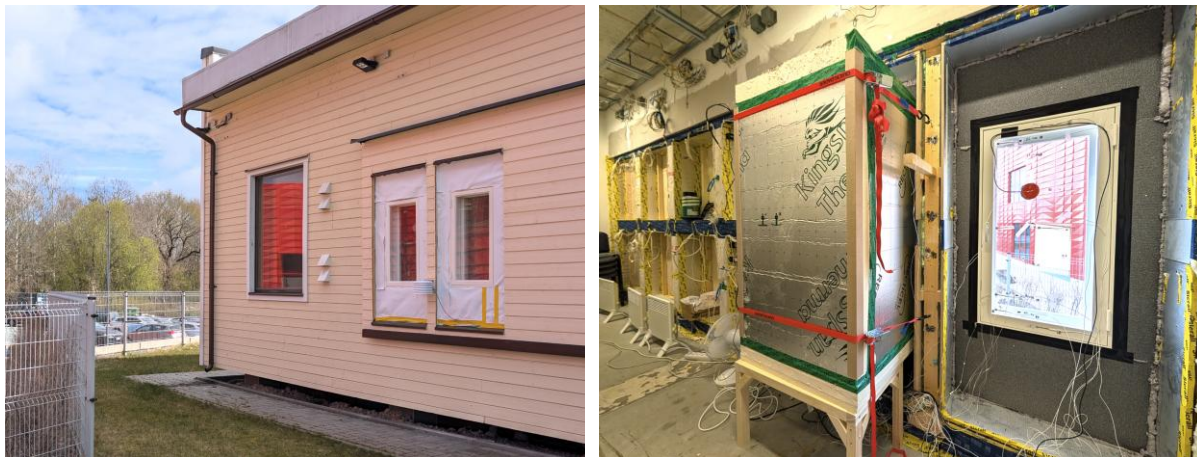
The thermal performance of the window prototypes was evaluated using a hotbox measurement system (see Table 13 and Figure 34) installed in the nZEB Test Building at TalTech. This setup allowed the windows to be subjected to real outdoor weather conditions while the interior boundary was maintained by a temperature-controlled hotbox, which itself was situated within a separate temperature-controlled room to minimize external thermal interference. The windows were installed within a wall consisting of 200 mm-thick expanded polystyrene (EPS). To calibrate the system and verify the thermal integrity of the installation, reference measurements were performed using a 200 mm EPS block in place of the window opening.

Figure 34 Windows being tested in the nZEB Test Building of TalTech. Photo from the outside (left) and inside (right): hotbox can be seen installed on the left window, heat flux and temperature sensors are visible on the rightmost window.

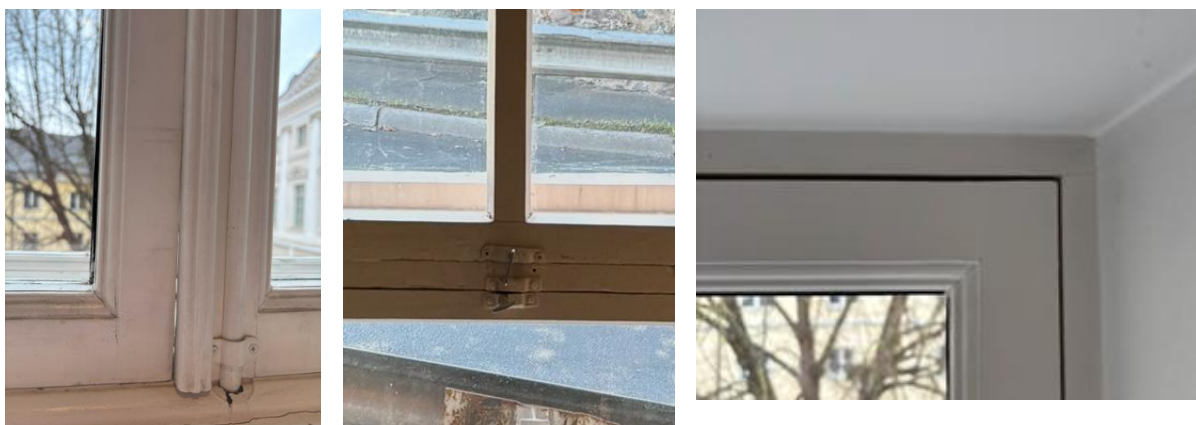
During visual inspection there were common remarks about windows (Figure 2):

- Missing or malfunctioning fastening elements
- See-through visible cracks
- Not symmetrical window frames and cracks between them. Frame doesn't sit correctly in jamb.

Figure 37 Technical state remarks. See-through cracks (left), missing fastening elements (middle), big gaps between jamb and frame (right)

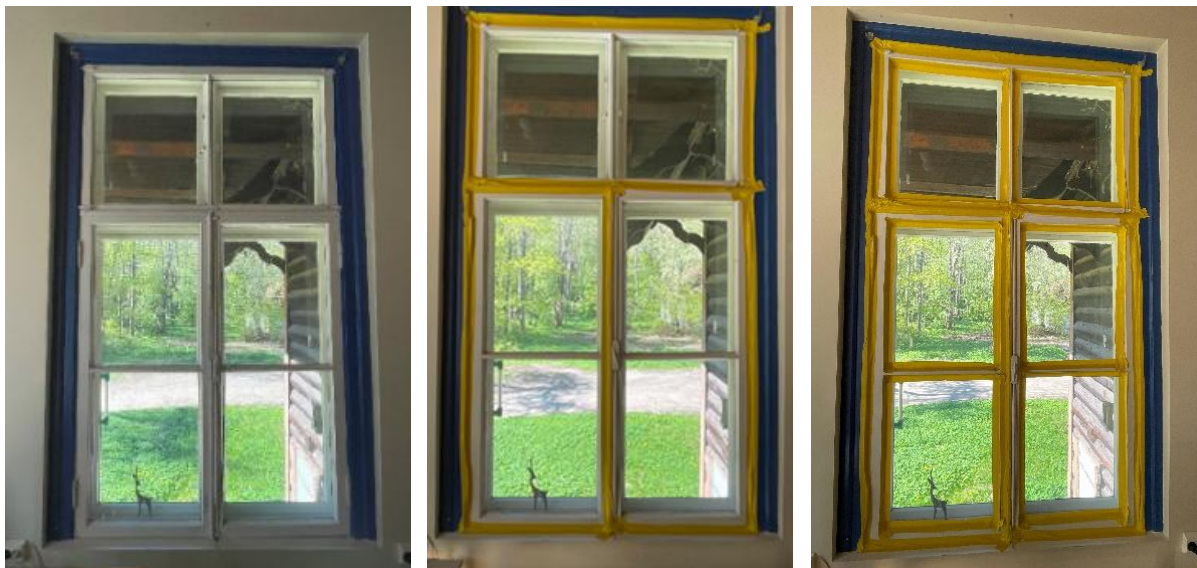
Figure 39 Air permeability at 50 Pa. Original (left) – 32,94 m³/(h·m²). Taped frame-jamb joint (middle) – 1,91 m³/(h·m²). Taped frame-jamb and frame-glass joints – 1,27 m³/(h·m²)

If windows are tightened and taped, then 46% of windows reach class 4. Therefore, we can say that main leakage comes from between the frame and jamb, not between the frame and glass (Figure 4). The other 54% of windows classify as class 3, 2 or 1 (Figure 3). Higher air permeability on some windows may be caused by tarpaulin placement to the jamb extension rather than window jamb itself, which may lead to excessive measured air permeability between wall and window jamb.

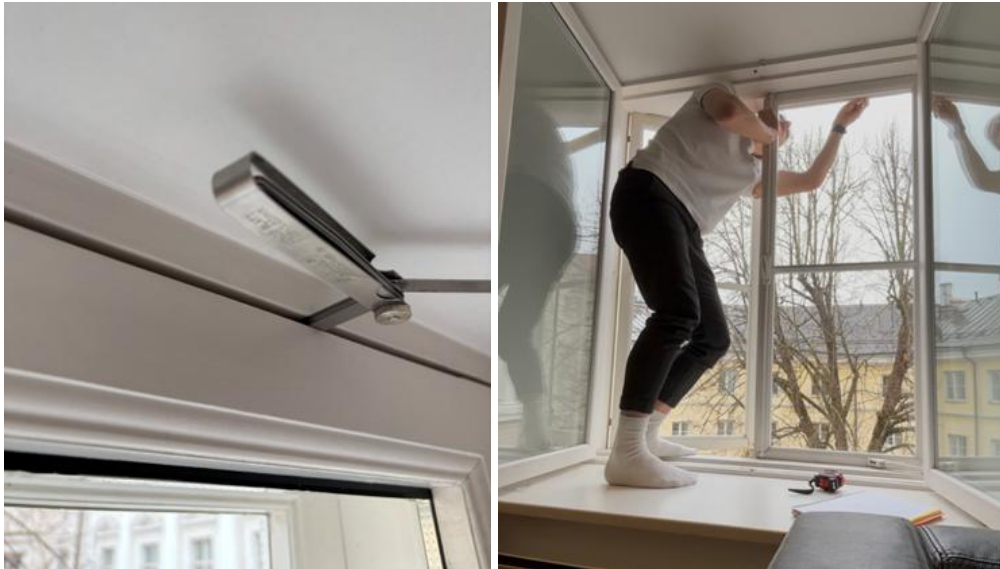
Figure 40 Measuring gap width with leaf caliper.

First calculations with 8 windows from 4 buildings show that it is possible to predict the air permeability using measurements of cracks between window frame and jamb (Figure 5). To achieve reliable results, measurements must be precise, as measuring errors as small as - 0.7mm to 0.3mm (Table 15) can alter the calculation outcomes as seen in practice. As previously mentioned, some air permeability measurements also include joints between wall and window jamb, which may distort measurement results and therefore complicate the comparison between calculated and measured data. The accuracy of calculated air permeability compared to measured data is 41% - 142% (Figure 41 & Figure 42). In these calculations there are three calculations that are quite close to measured data, and this gives hope that we can use this method in the future, but this calculation method needs further testing in laboratory to see how reliable it is.

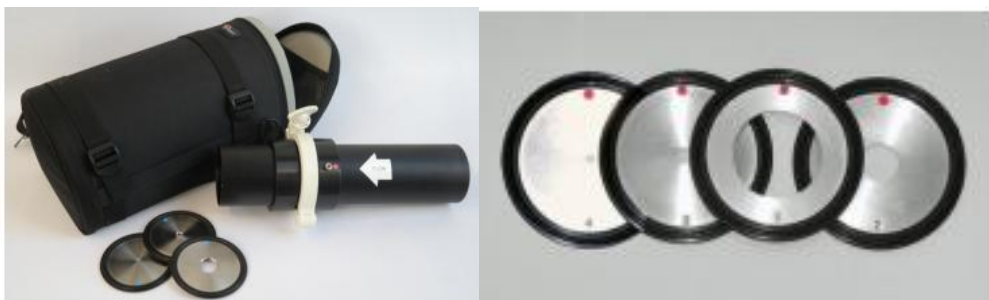
Figure 43 Micro Leakage Meter (MLM) and 4 disks with different size of opening diameter

- 1 Minneapolis Micro Leakage Meter (MLM)
- 2 Connecting hose to the ductwork
- 3 Silicone tube, transparent (10 m) with capillary tube [for determining the pressure in the ventilation duct]
- 4 USB cable [connection DG-700 – laptop]
- 5 Fan control cable [connection DG-700 – fan speed controller]
- 6 Digital pressure gauge DG-700
- 7 Set of silicone tubes, red and blue (3 m each) [connection MLM – DG-700; determining the MLM pressure differential]
- 8 Fan speed controller for DuctBlaster B
- 9 Connecting hose to the DuctBlaster fan
- 10 BlowerDoor fan DuctBlaster B with hose connection plate

The airtightness was measured with a Micro Leakage Meter (MLM) Measuring System (Blower Door GmbH, 2016) and a spot-made test device around the window. The MLM is often used for tests on duct systems and measures the air flow to the tested component by measuring the pressure difference before and after one of the four disks, each calibrated for a specific pressure difference and air flow range, and can conduct measurements with small air flows of 0.17 to 78.5 m<sup>3</sup>/h and high pressure differentials (up to 250 Pa).

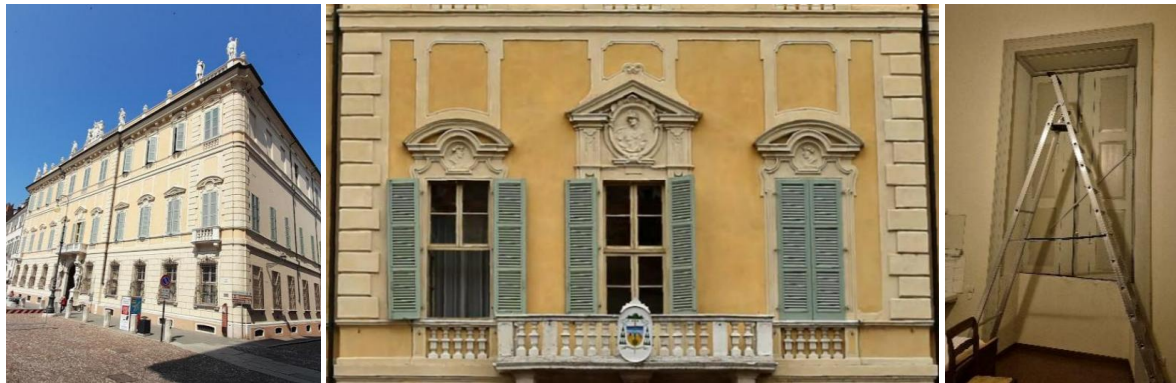
Figure 45 Case study Palazzo Vescovile

The studied windows at Palazzo Vescovile are reconstructions of the single windows, with insulation glazing. They have a size of nearly 4.5 m<sup>2</sup> - with an approximative width of 1.4 m and a height of 3.2 m. The length of joints according EN 1026 results in 14.8 m. The

windows do have a wooden cladding of the reveal which includes also interior shutters. The closure of the latter does not seem airtight, the gaps all around amount to 5 to 10 mm.

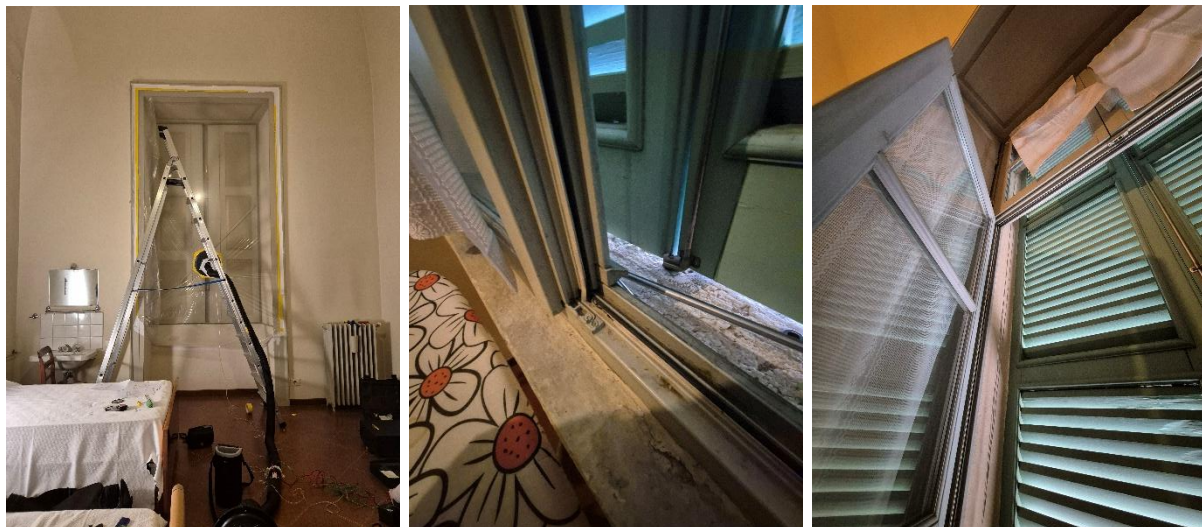
Figure 46 Air-tightness measurement build up at Palazzo Vescovile and detail of window showing double glazing and exterior shutters

All tests have been done with closed exterior shutters. Figure 46 shows that these are the typical Italian style with lamellas and considerable open space. As regards the interior wooden shutters, the test has first been performed with shutters. For a second test the interior shutters have been opened - not completely as this would have meant finding a new position for the foil, but with an opening distance of ~200mm in the middle between the two shutters.

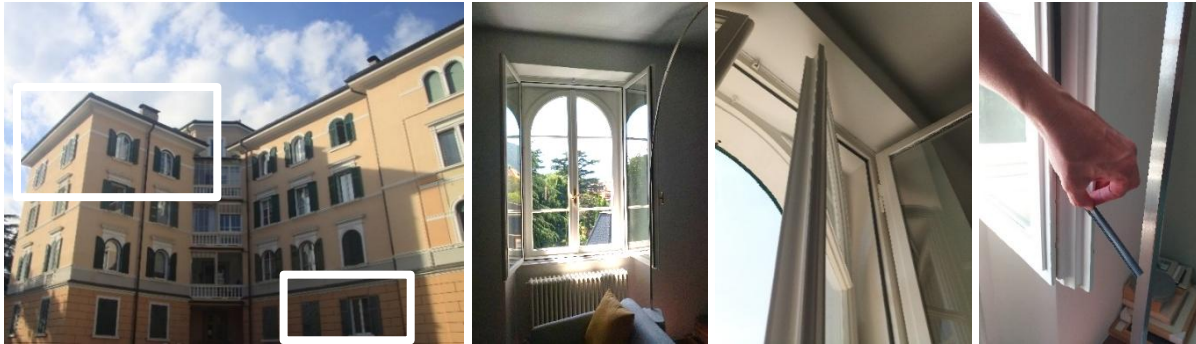
Figure 48 Railway Workers House in Bolzano/IT, with indication of the measured windows. Photos of the refurbished window with “Wolfsrachen” and the sealing of the inner window.

The Railway Workers House in Bolzano/IT dates from the 1920ies and was constructed by the Italian Railways for their employees when South Tyrol became part of Italy after the First World War. Several construction techniques are typical rather for Norther Italian tradition than for South Tyrol – so is the interlocking rebate (Wolfsrachen; see Figure 48 and Figure 49).

The windows in the flat on 3<sup>rd</sup> floor marked in Figure 48 had been refurbished in 2017: Besides improving them energetically with replacing the single glass in the inner layer with double glazing, an important aspect was that the distorted frames were repaired. The air-

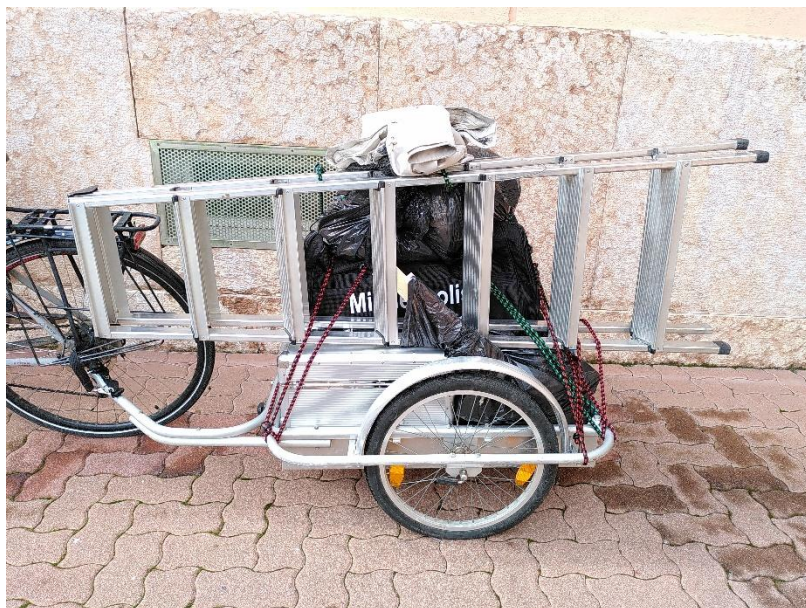
Figure 51 Practical aspect: Transport of MLM equipment with bike trailer is possible

The testing method with MLM has proven to be well implementable with some limits: the transport of the equipment to the site does not need particular means, the measurement can also be done on windows of buildings in use without too much hassle for the tenants. Limiting factors are (i) the maximum power of the here used fan – especially for big and leaky windows (Palazzo Vescovile, not retrofitted window at Railway Workers house) and (ii) the observed detachment of the tape especially with measurement under pressure. Attachment was more stable when done on the wall and not in the window reveal. This led, however to a bigger air volume between foil and window and the need to approach the next pressure point gradually and very carefully with manual operation of the equipment.
